Measure to Monitor

*(a sub-project of Smarter Irrigation in SA)
South East, South Australia*

A weekly review of irrigation sensor and pasture growth data to improve irrigation scheduling throughout the year.

11 January 2018

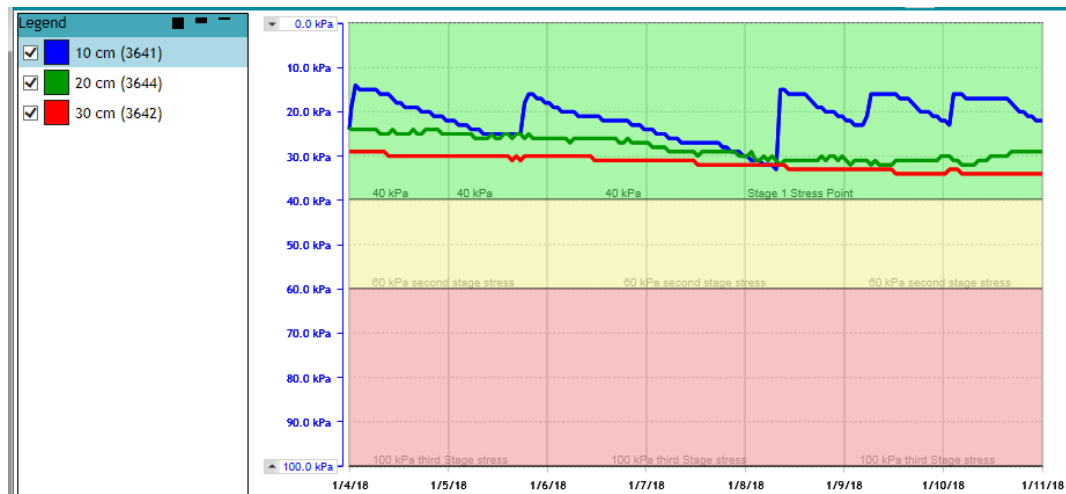
Allendale East:

Sensors are tracking nicely - all within the desired moisture range.

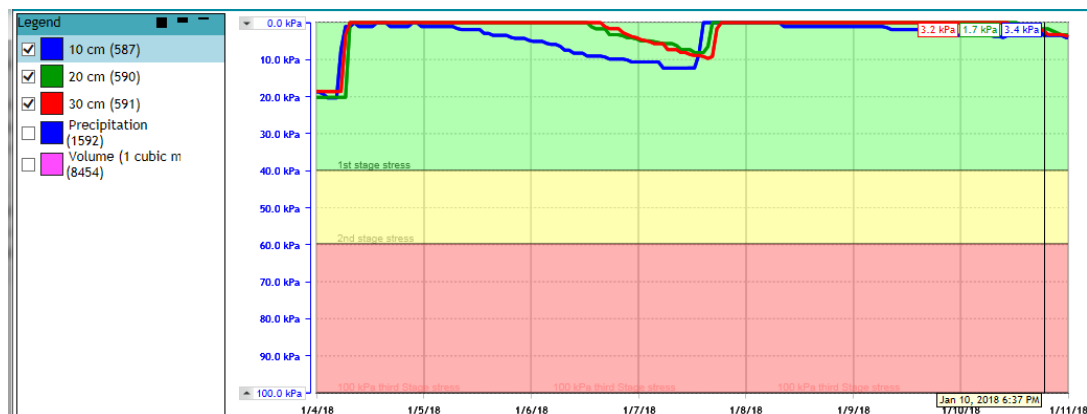
Mt Schank

The sensors are tracking the same as last week.

From discussion with Tim Powell last week, it seems that the current sensor location is in heavier soil than the previous one, although still in the same pivot. In line with typical RAW values for this pivot, a low rate of irrigation is being applied frequently. In lighter soil, such as at the other sites, a distinct peak is seen for each irrigation. At this sensor location, however, the soil can absorb more water and the rate of irrigation is not sufficient to produce individual peaks in soil moisture. In this case, the thing to look for is the trend over time. In the chart above, soil water has been fully replenished twice during the week.

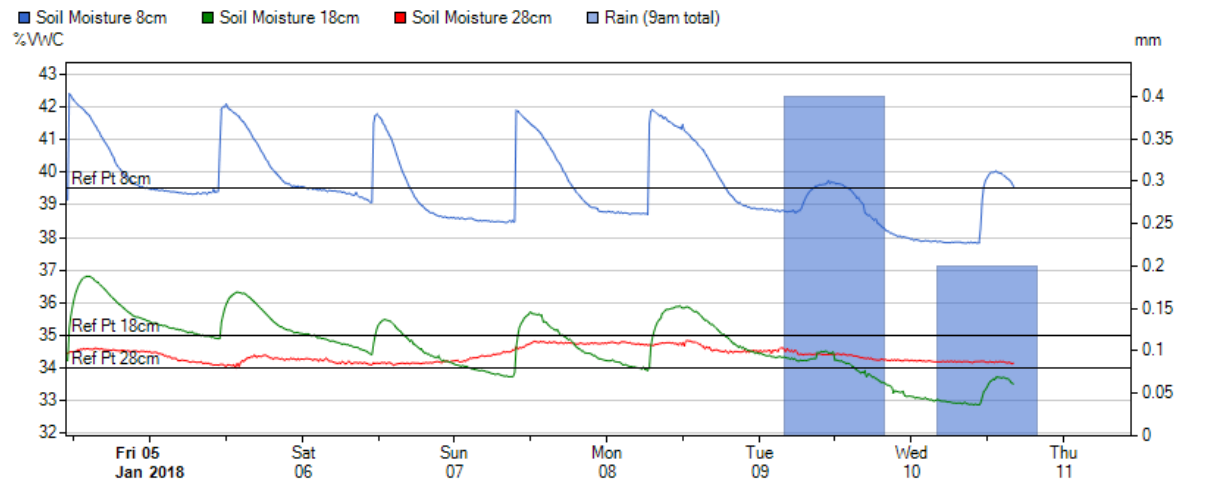
Dry Area

Data looks good, irrigation water is not getting past the root zone. Irrigation may have been skipped over the last 2 days due to rain or heavy dew.

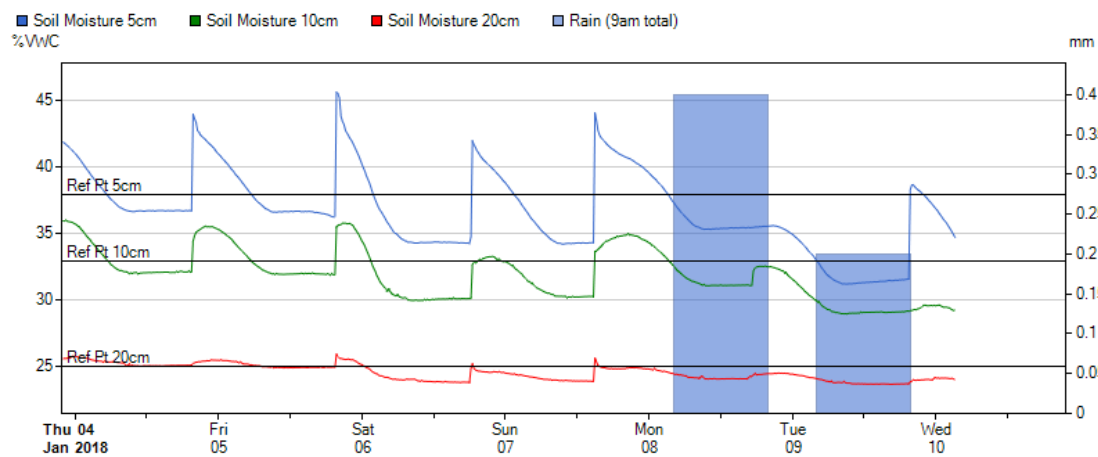
Normal Area

Sensors are reading OK, producing smooth lines of soil moisture. Slight drying over the last two days as per Dry Area.

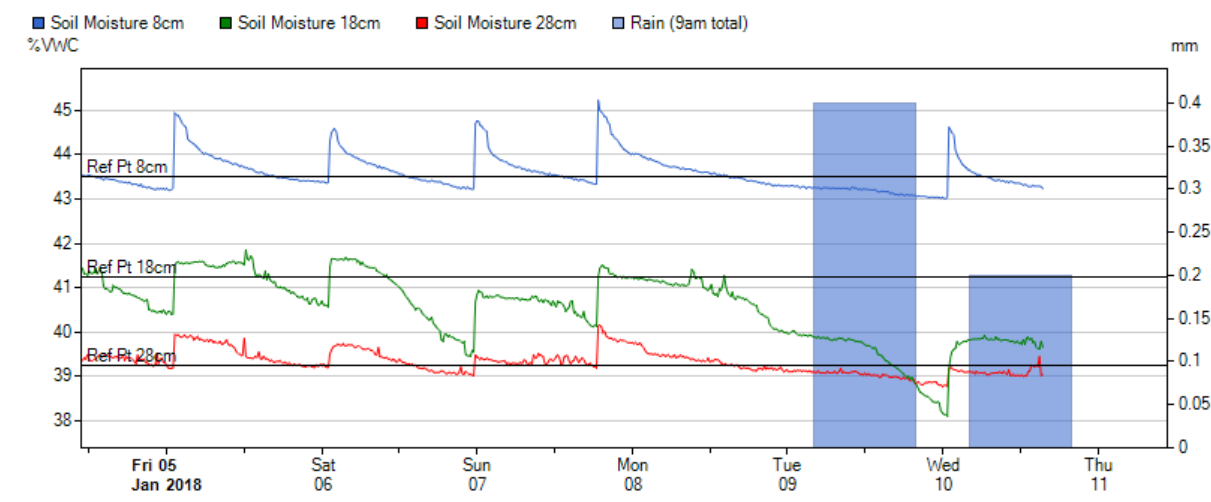
Wet Area

Data from the two deeper sensors is giving a jagged, or "noisy" trace on the chart. It is hard to know at this stage whether the sensors are reading fine and just have a bit of noise, or if they are actually

not reading correctly. The fact that all peaks occur at the same time, and that the moisture trends are similar between depths is reassuring. It would be good to be able to get a smoother output from the sensors, though.

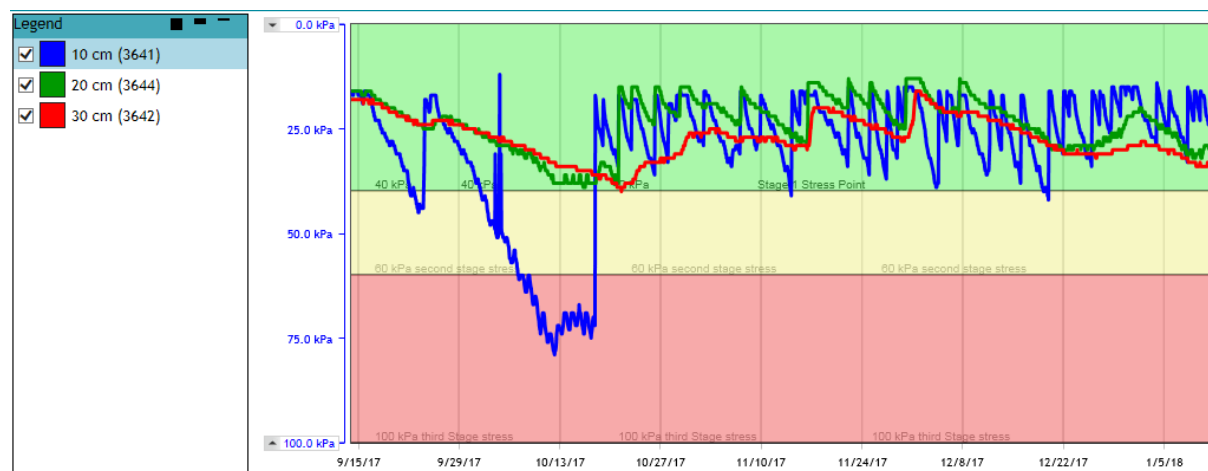
Allendale East

the above chart shows soil moisture readings from September through to current (January). Soil moisture readings have been maintained closely within the desirable range throughout. The shallow sensor (10cm) became quite dry in mid-October. This would not have affected pasture growth, however as there was adequate soil moisture elsewhere in the root zone. There was an odd spike in surface soil moisture from the 10cm sensor in early October. This was not repeated, though, and was probably just a random event (e.g. urine splash from a cow). Overall, the sensors are stable and seem to be well integrated with the irrigation scheduling.

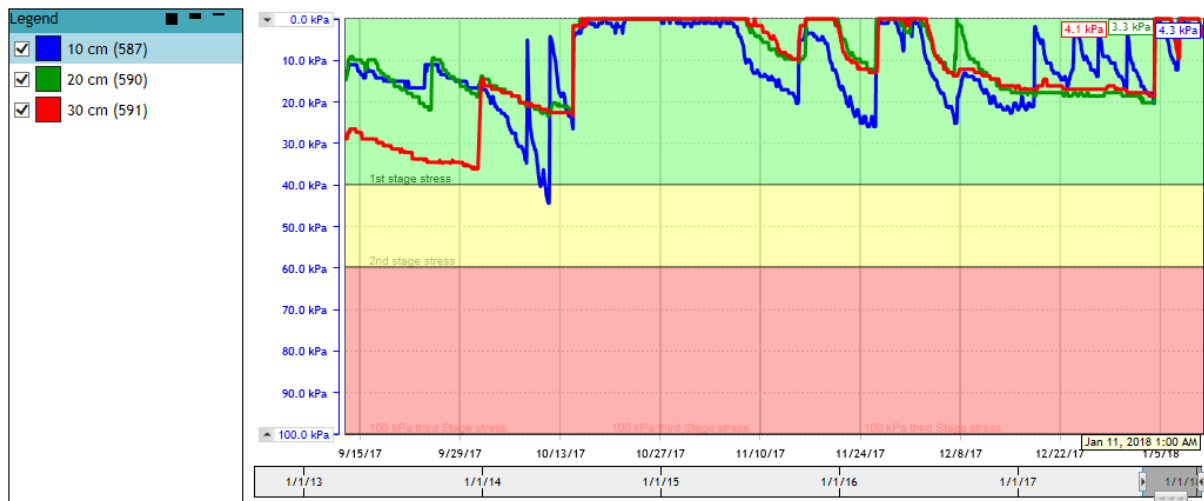
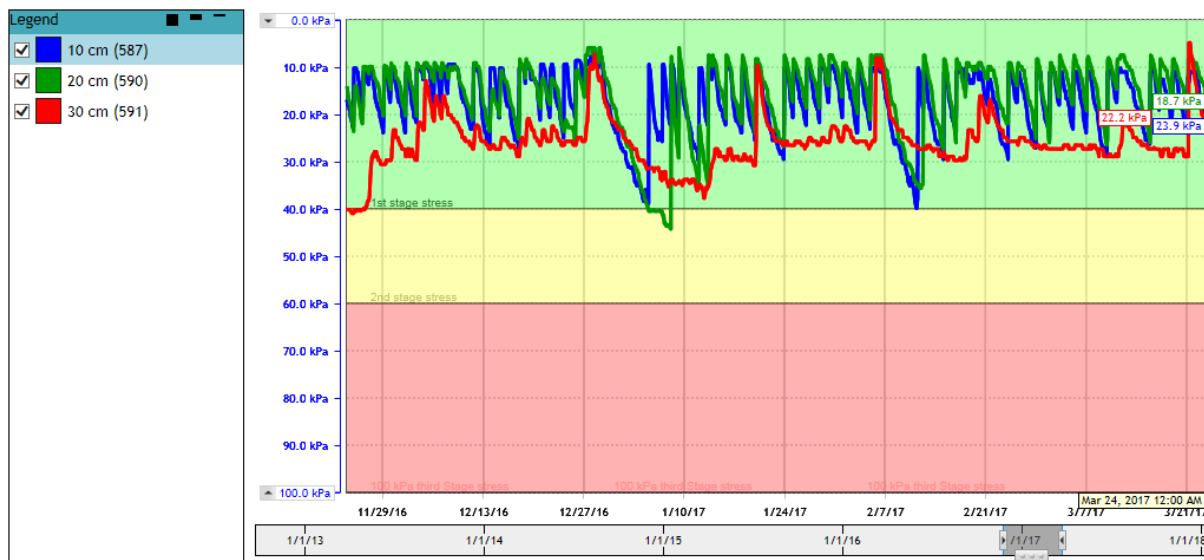
Mt Schank

In October last year, the sensors were moved to another part of the centre pivot at this site. This was done in order to better monitor soil moisture in newly sown pasture. The recorded soil moisture changed from distinct peaks (as seen in the chart below from last year) to more slowly changing soil moisture which did not show individual peaks for watering events.

As discussed above, this is likely due to a heavier soil type at the new sensor location. From previous discussion, the key to interpreting the new trace is to watch for the change over time. Gradually dropping soil moisture over time shows that the irrigation is not keeping up with pasture use. Stable or gradually increasing soil moisture shows that irrigation is adequate for pasture growth. Within that framework, soil moisture seems to have been well maintained at this site during the irrigation season.

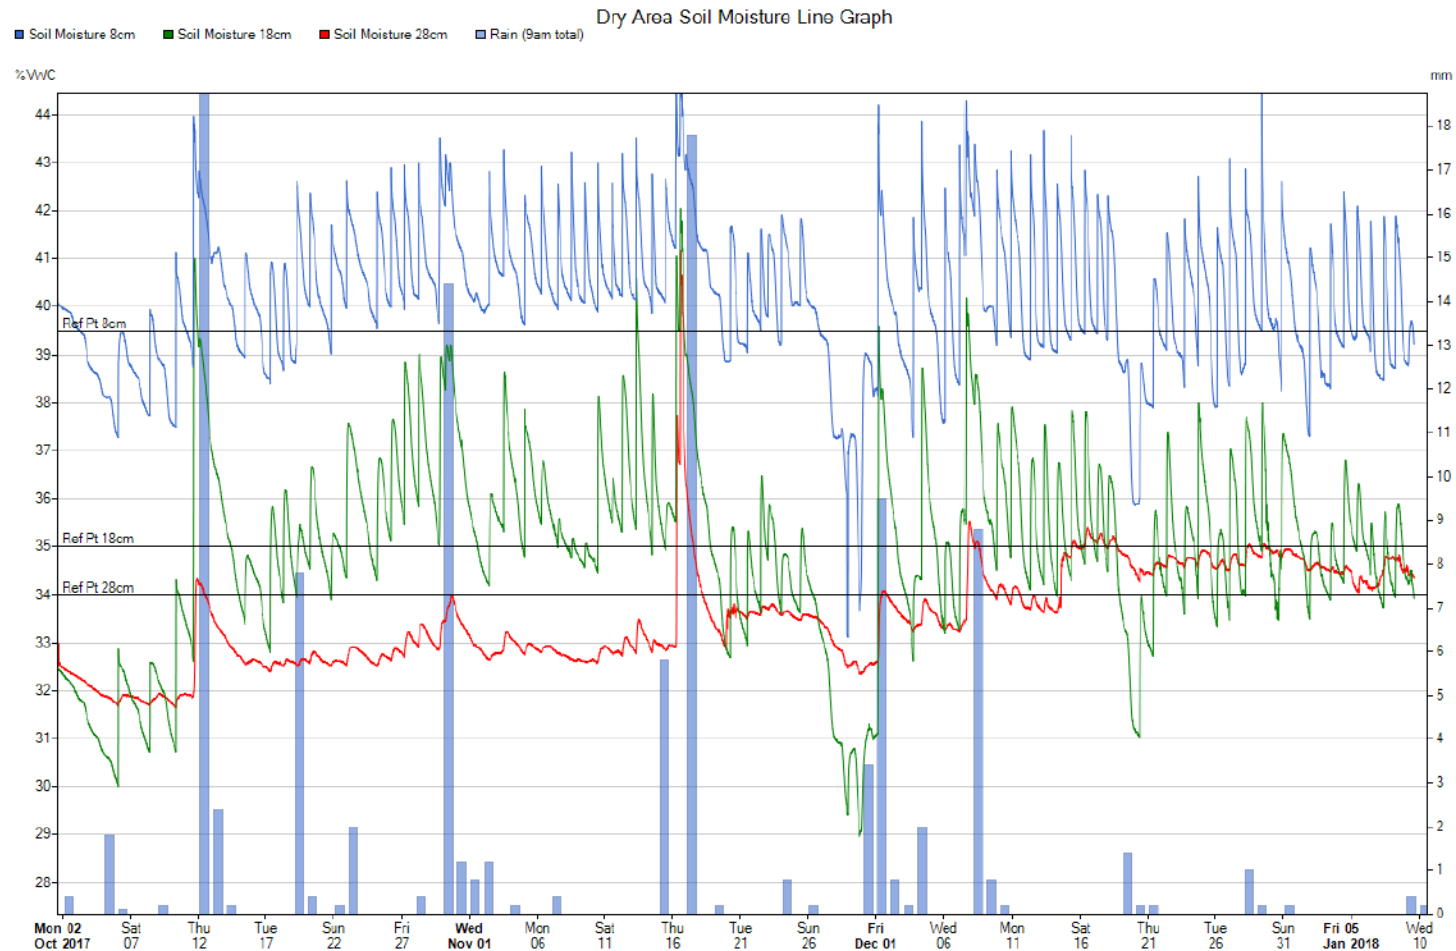
Dry Area

There is a lot to look at here. Firstly, the baselines (reference points) for each sensor seem *reasonably* stable, compared to the other locations. By this I mean the lowest parts of each peak, where the soil moisture drops back to after each irrigation. Even so, it seems a bit difficult to interpret, given the lack of soil moisture suction (kPa) as per the other sites.

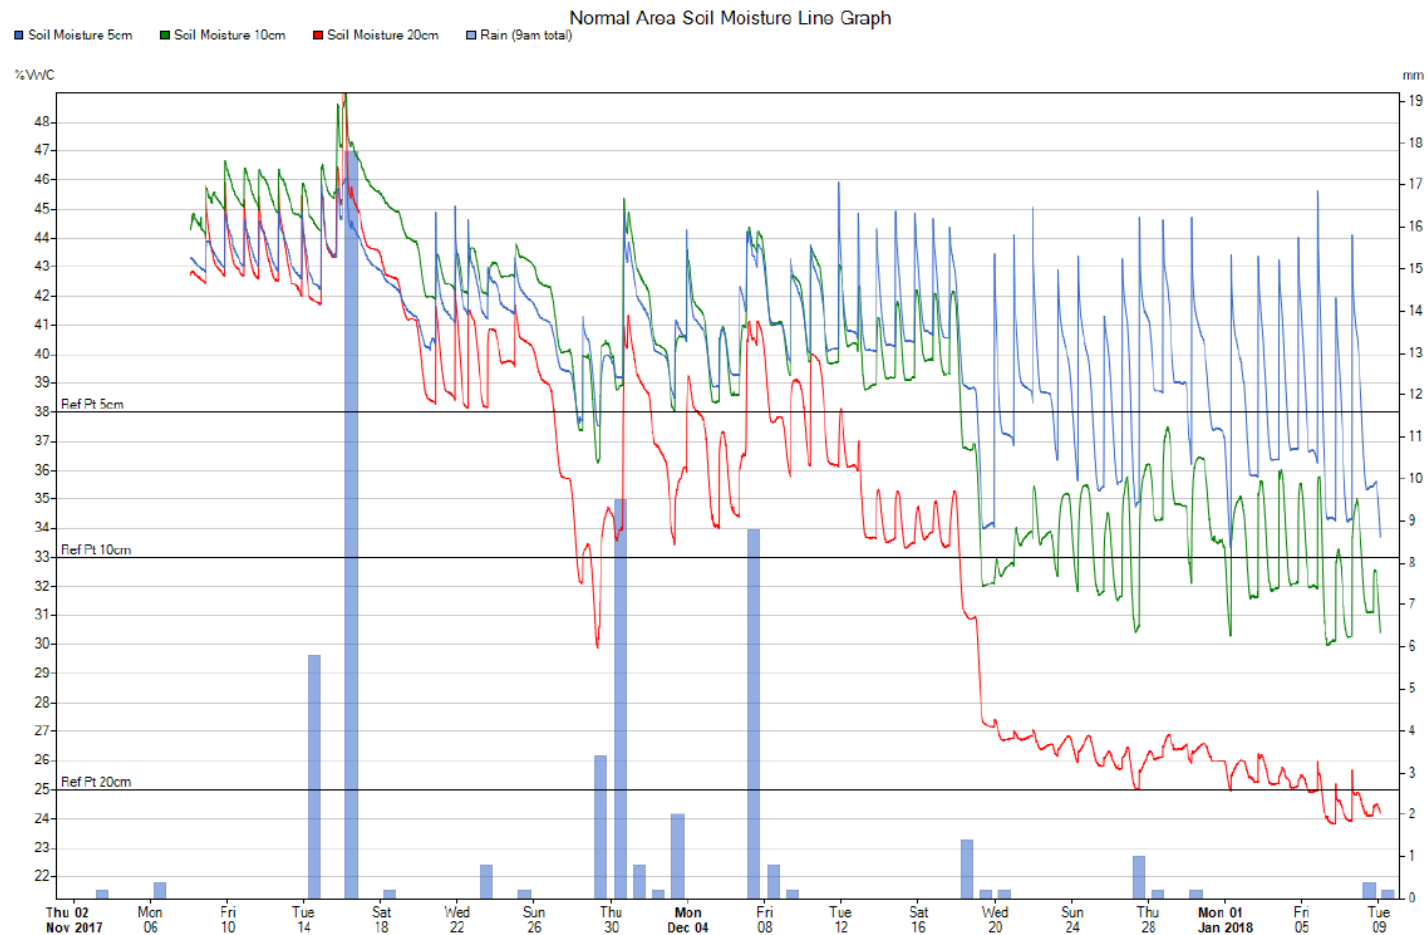
Normal Area

The soil moisture baselines at this location have changed dramatically over the irrigation season, and have dropped several times since November. Frequent assessment of previous data and updating of reference points would be needed in order to use these sensors as irrigation triggers. This would involve a lot of time and effort.

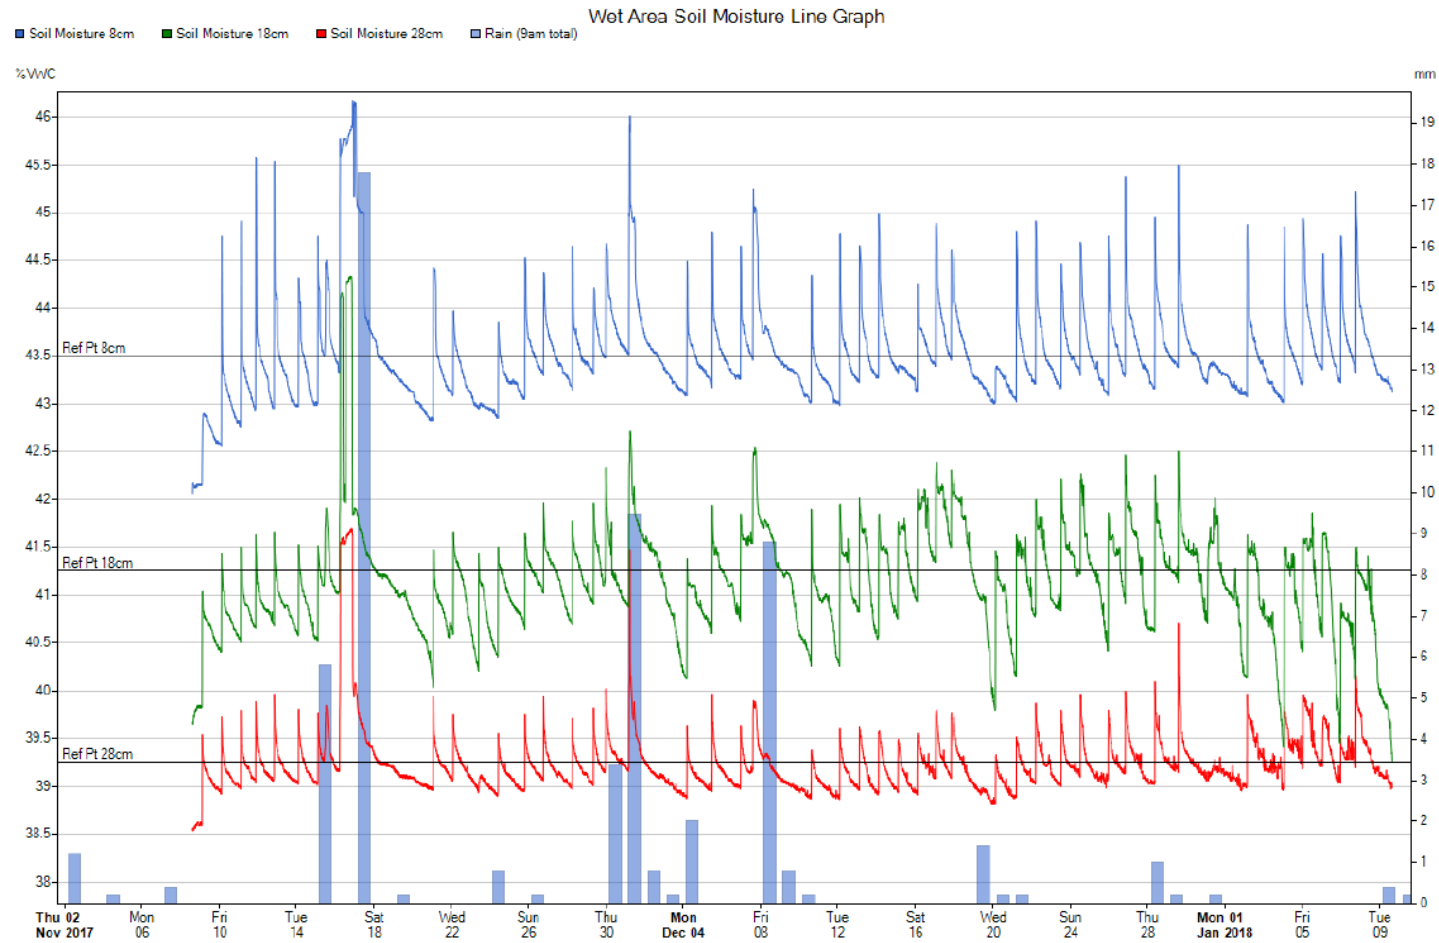
Wet Area

These sensors have probably the most consistent soil moisture traces on this centre pivot, although data from the two deeper sensors has become a bit noisy over the last few weeks. The soil moisture at all depths has been maintained in a fairly consistent range during the irrigation season.
