Smarter Irrigation for Profit Project

Hunter Optimised Dairy Irrigation Farm (NSW)

‘Glenhaven’ Irrigated Pasture Update

October 2017

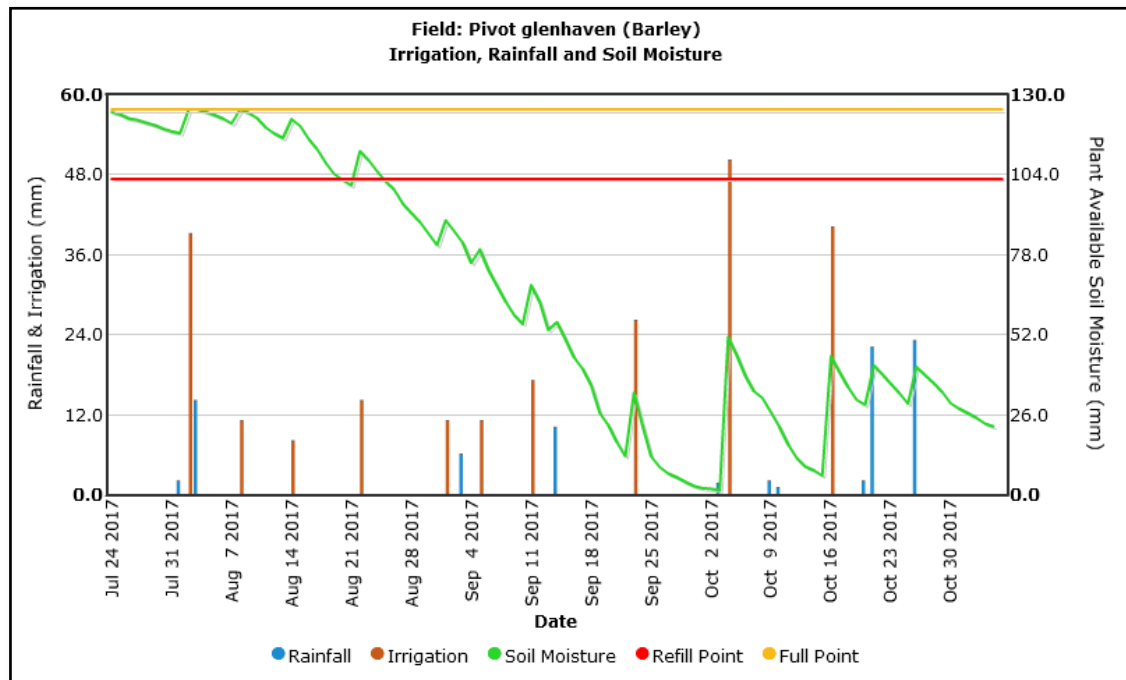
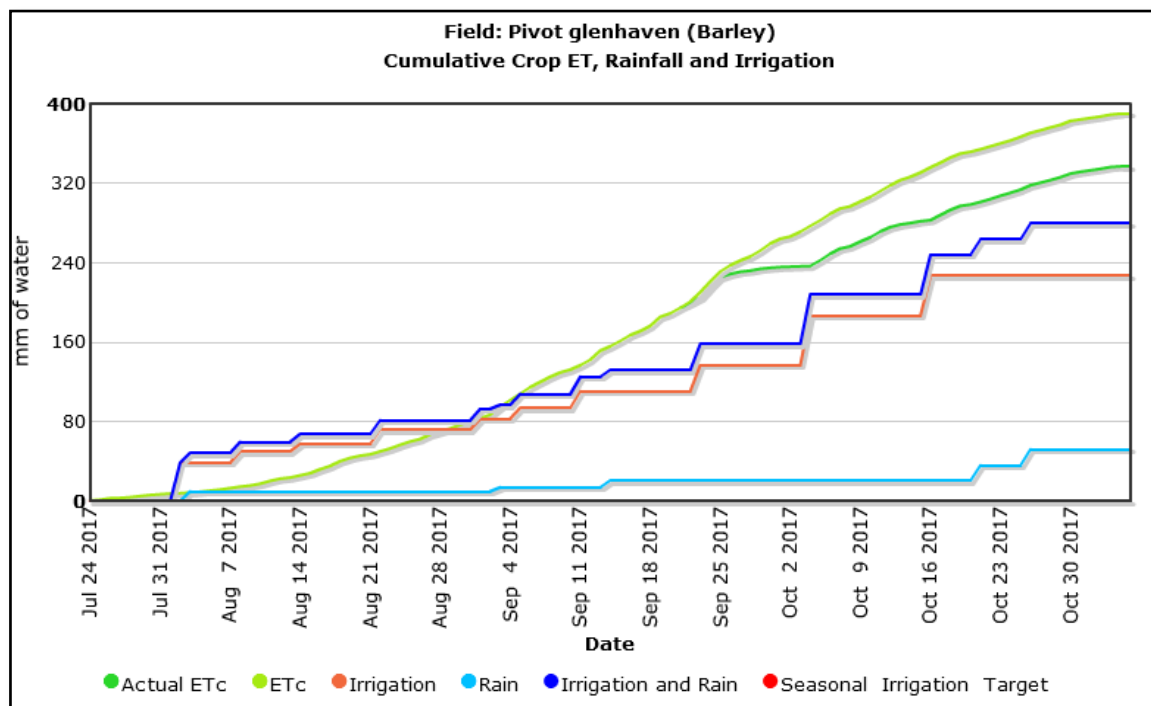
Seasonal summaries from the Scheduling Irrigation Diary (SID) for Glenhaven

The seasonal summary of irrigation, rainfall and soil moisture from the Scheduling Irrigation Diary (SID) on page 2 demonstrates the pasture growing season of the second half of winter/ beginning of spring. The aim of the irrigation was to grow the Barley-Lucerne pasture in readiness for an October hay harvest. As the winter was so dry, the decision was to apply more irrigation than usual. However, an evaluation of the irrigation system revealed that the control panel of the centre pivot indicated about 44% more water was being applied than actual (ie. control panel was set to apply 70mm per pass but in fact 38mm was being applied- refer to Centre Pivot Evaluation Report section on page 5). Hence the soil profile was mined of water.

While manager, Scott Wheatley, was satisfied with the harvest yield achieved, the seasonal summary indicates there was potential to have increased yield if the actual water applied was in accordance with

what was programmed into the control panel. Alternatively, the same yield could have been achieved using the same amount of water applied over a shorter duration each day, saving on expensive power usage.

The cumulative crop ET, rainfall and irrigation summary (below) demonstrate the shortfall of applied water of approximately 100 mm when harvest occurred on the 12th of October.

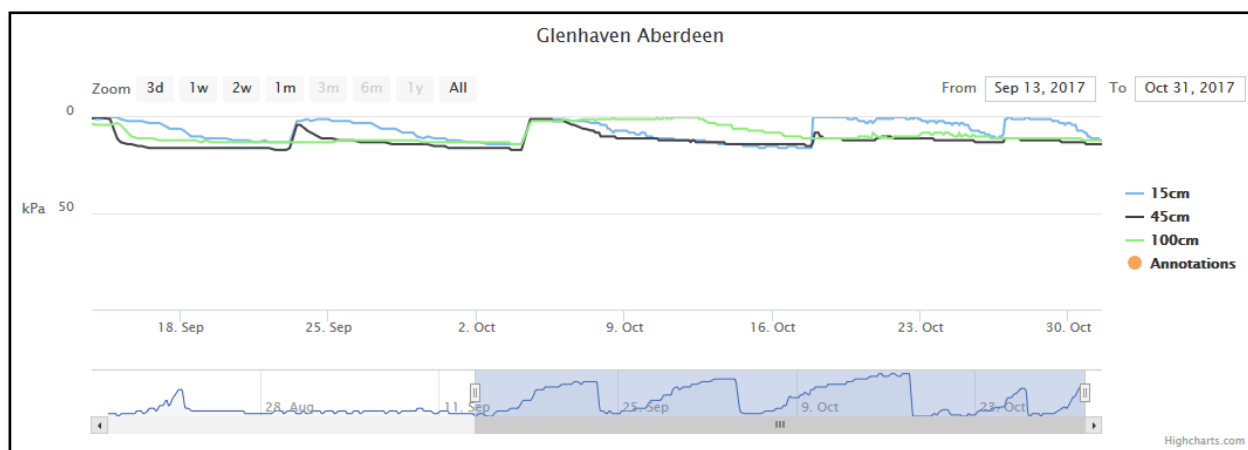
Glenhaven soil probe traces as at 31/10/17

The soil moisture probes under the Glenhaven centre pivot were installed on 14 September. The locations were determined by undertaking EM38 mapping of the site, characterisation of the soils using deep soil coring methods and soil nutrient analysis. The EM38 mapping can be found [Here](#) and results of the soil coring [Here](#).

All three sensors have readings in the range of -1 to -17 kPa indicating moist soil. Readings of -8 to -10 kPa indicate Field Capacity, and readings greater than this indicate plant water use, so these readings suggest that the soil was saturated for significant periods. The three kicks on 23 September, 4 October and 17 October are in response to irrigation events of nominally 46 mm, 90 mm and 40 mm respectively. Evaluation of the centre pivot showed that it was supplying 44% less water per pass than the control panel indicates, so these three irrigations actually applied 26 mm, 50 mm and 22 mm respectively. The fourth kick on 27 October is in response to a rain event of 23 mm. The shallow 15 cm sensor (blue line) displayed waterlogging after each watering event, then a steady pattern of water use by the crop. The waterlogging was for periods of three to five days which is longer than would be expected for this soil type (Light Medium Clay) and the usage pattern following the first two irrigations was slower than expected for the crop growth stage and warm conditions experienced for the growing period. The irrigation on 23 September penetrated to the 40 cm sensor (black line) but drained more quickly than the soil at 15 cm, which is to be expected as the second soil layer is lighter than the top layer. This trace then displays a slow water use by the crop. This irrigation did not penetrate to the 100 cm sensor (green line) and there is no indication of water use from this depth. The irrigation on 4 October was double the amount of the previous one and all three soil sensors indicate that water reached them. All three traces are fairly flat for the first three days afterwards so the soil profile was fully saturated. The 40 cm sensor (black line) drained the fastest while the 15 cm trace (blue line) displays waterlogging for another day or so. The 100 cm sensor

(green line) shows waterlogging for about 8 days until 12 October after which drainage commenced. This to be expected as the soil at this depth is heavier than the middle layer. As the trace did not go below -8 kPa, it is not possible to determine if there was crop water use at this depth. The irrigation on 17 October was after the field had been cut. The 40 cm sensor (black line) shows that this irrigation just reached this level, but most of the water was retained in the upper layer which had prolonged waterlogging (blue line) for six or seven days. The water use of the crop was lower following the fodder being cut which would contribute to the extended period of waterlogging. The rainfall event on 27 October appears not to have penetrated beyond the first layer either, but the waterlogging period was much shorter and the pattern after this shows more vigorous crop activity resuming.

The soil moisture probes were installed during the dry winter and therefore have probably not fully equilibrated with the soil profile. Readings are considered not fully reliable in this early stage but confidence will increase over the project study period.

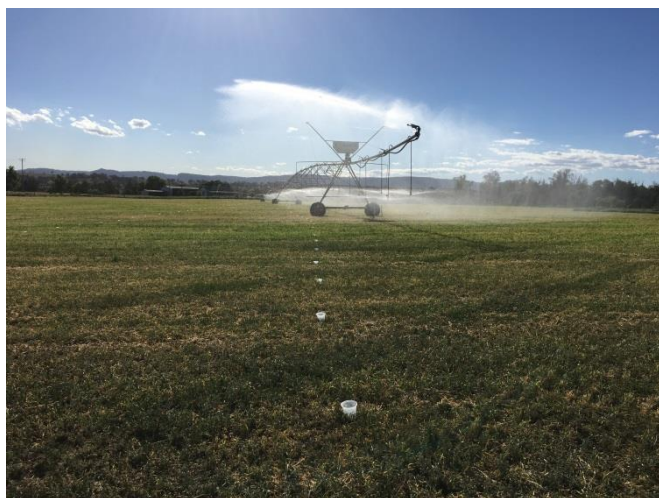
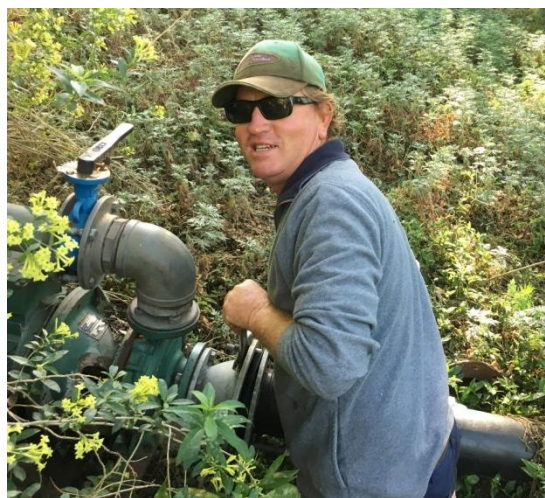
A catch-can test was undertaken as part of the irrigator performance evaluation (left) & Glenhaven manager, Scott Wheatley, assists irrigation consultant, Peter Smith, with pump efficiency testing.

During the month of October an irrigator performance evaluation report was undertaken of the study centre pivot.

The key findings were:

- The configuration of this system is substantially different from the specifications so meaningful comparison of the performance is either not possible or questionable. It is recommended that the entire sprinkler package be re-specified.

- This system is applying 44% less water than the control panel indicted per irrigation.
- The Distribution Uniformity (DU) was 61% and the Coefficient of Uniformity (CU) was 73%. There is room for improvement and some steps that would help include repairing leaks, ensuring all sprinklers are straight, half-throw sprinklers are pointing in the right direction, replacing the 15 psi regulators on the overhang with 10 psi regulators to match the rest of the system, and adjusting the end-gun angle of throw.

- The Design System Capacity is 15 mm per day which is ample for the pastures being grown.
- The pump efficiency is 52% where the performance chart indicates it should be about 71%. If the pump was operating at 71% efficiency, the energy usage would decrease by 36%. It is recommended to investigate the cost-benefit of repairing or replacing the pump.

- The pump pressure and the flow rate gradually decreased over the duration of the field test. It would be worthwhile investigating a self-cleaning filter for the suction pipe.

- The height of the pump above normal water level is close to the limits for suction lift. Locating the pump closer to the water source should be investigated.

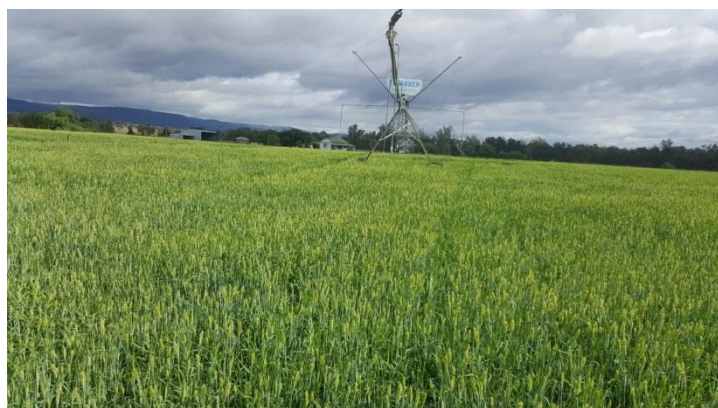
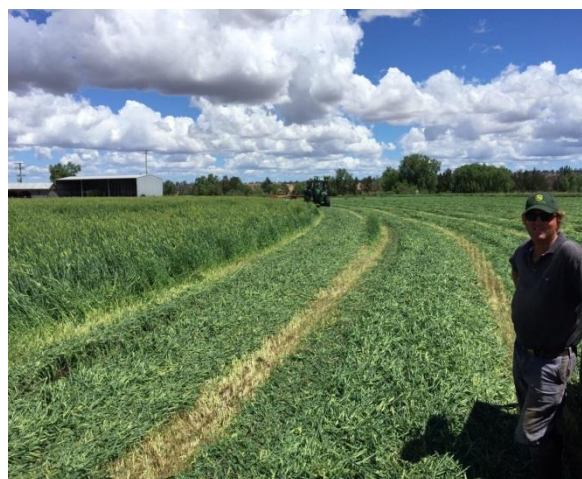
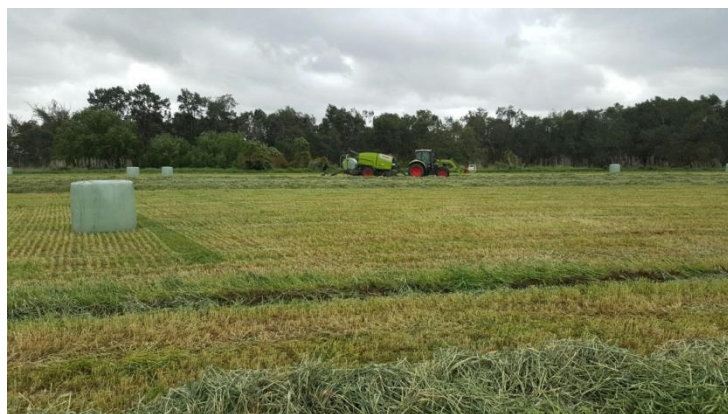
Barley crop under the 13.5ha irrigator was harvested in October. Whilst Scott was pleased with the results, there was perhaps potential to have increased yield if the water applied had not been 44% less than what was indicated on the control panel- lost opportunity?

Pivot Area (ha)	Hay/Silage Produced	Average Bale weight	Date Baled
10.29	166 Silage Round Bales	464kg	14 th October
3.07	25 8X3X3 Hay Bales	333kg	19 th October

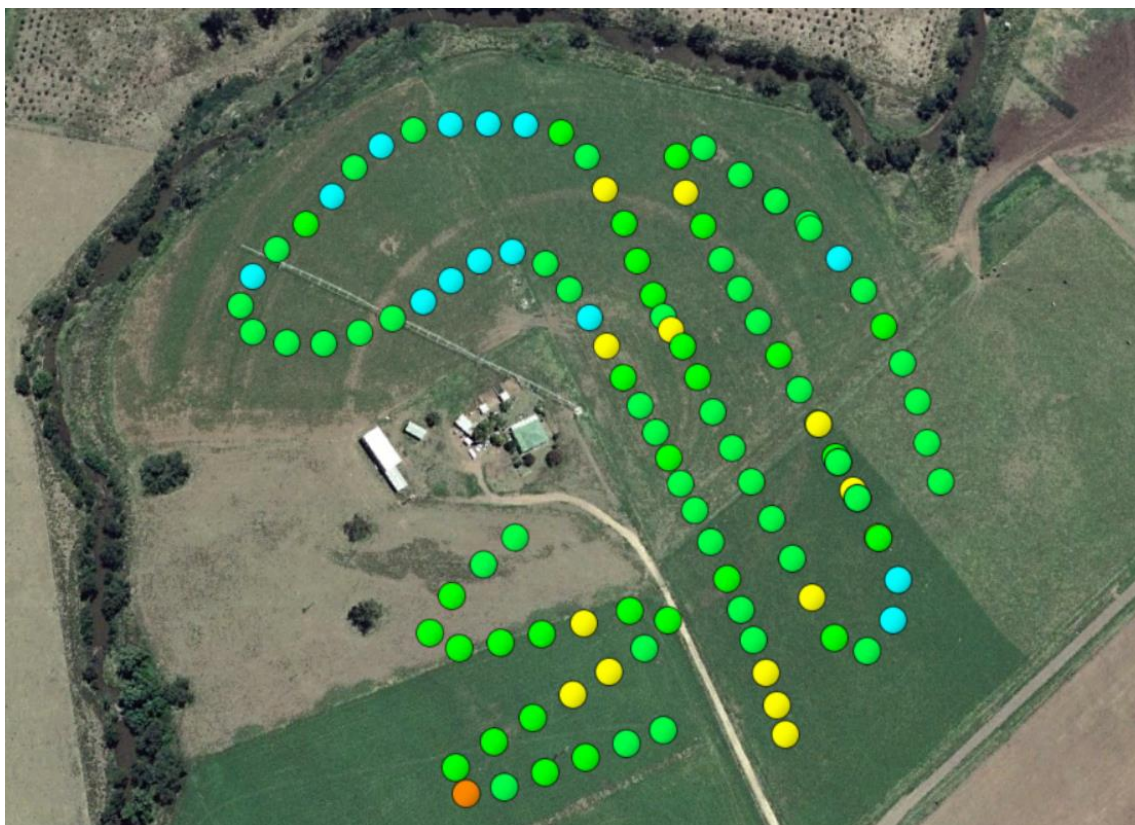
Photo: Pasture readings taken across the pivot area.

Legend Pasture Cover 6th November 2017

Dot Colour	Dry Matter (kg/ha)
Blue	3000+
Green	2000-3000
Yellow	1500-2000
Orange	0-1500

The dry matter under the pivot was measured before grazing commenced on the 7th November with the electronic pasture meter. An average dry matter of 2185kg/ha was measured with a range across the paddock. A minimum of 700kg/DM/ha was measured with a maximum of 3330kg/DM/ha. This reflects the age of the Lucerne stand, recovery from the hay/silage operation and the lower depressions in the paddocks causing the Lucerne to die out.

The pasture is measured using an electronic pasture metre with GPS reference points to determine pasture dry matter. To calibrate and ensure an accurate reading is obtained quadrant cuts are taken across the paddock.
